Beaver Kill & Willowemoc Creek Flood and Resilience Study

Stakeholder Information Gathering

January 15, 2026

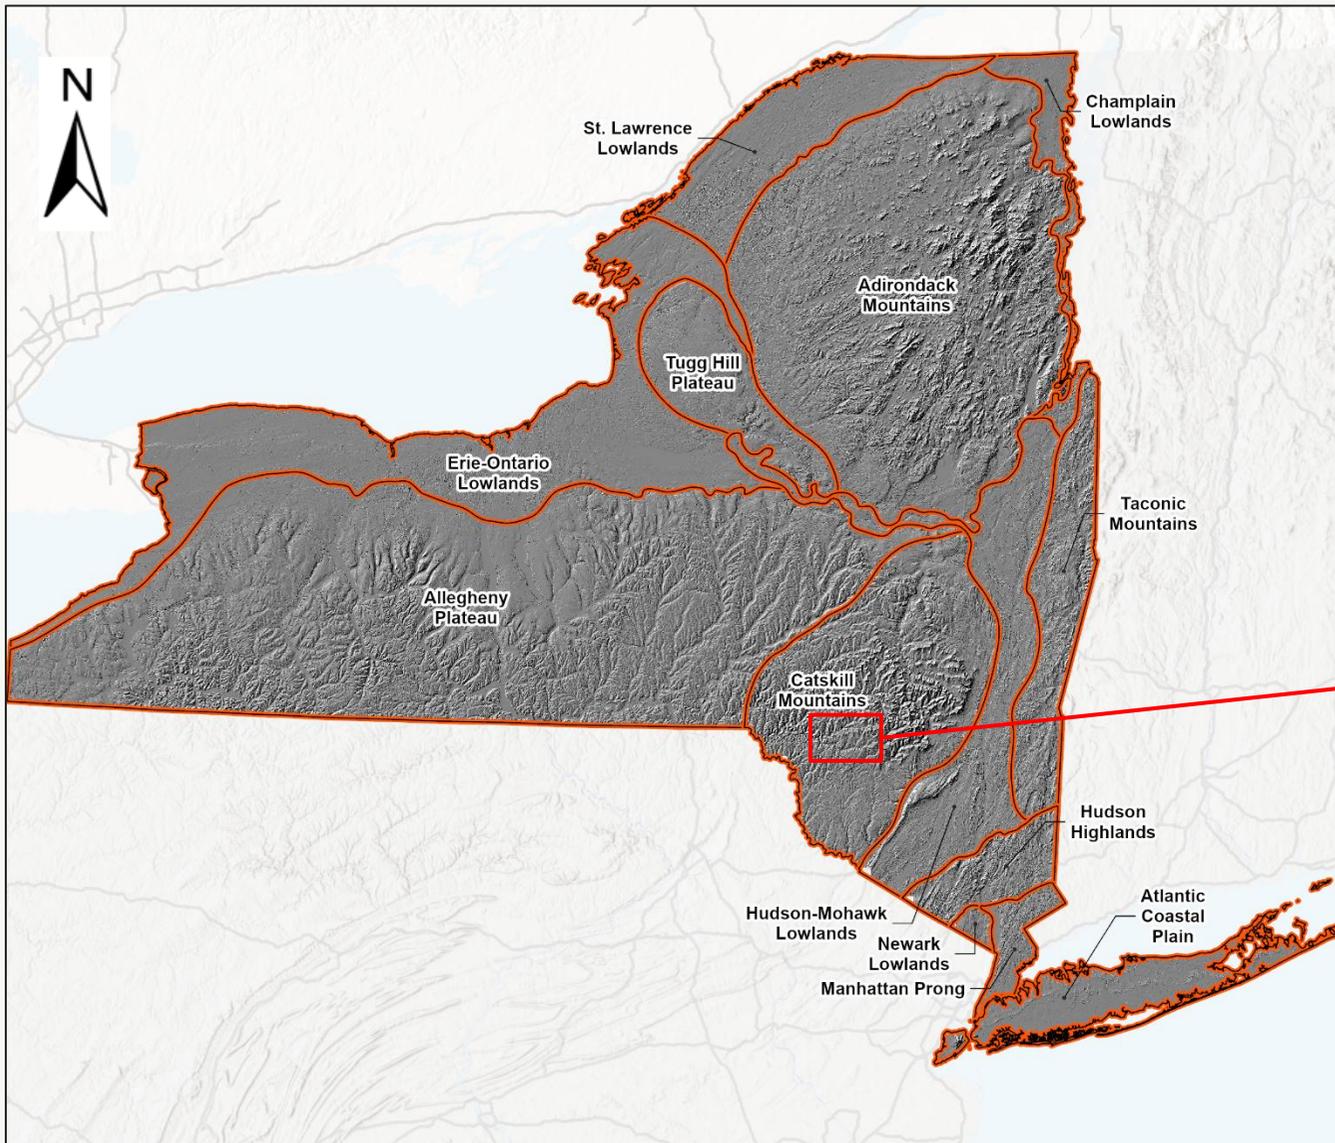
Beaver Kill Watershed
Drainage Area = 97.3 square miles

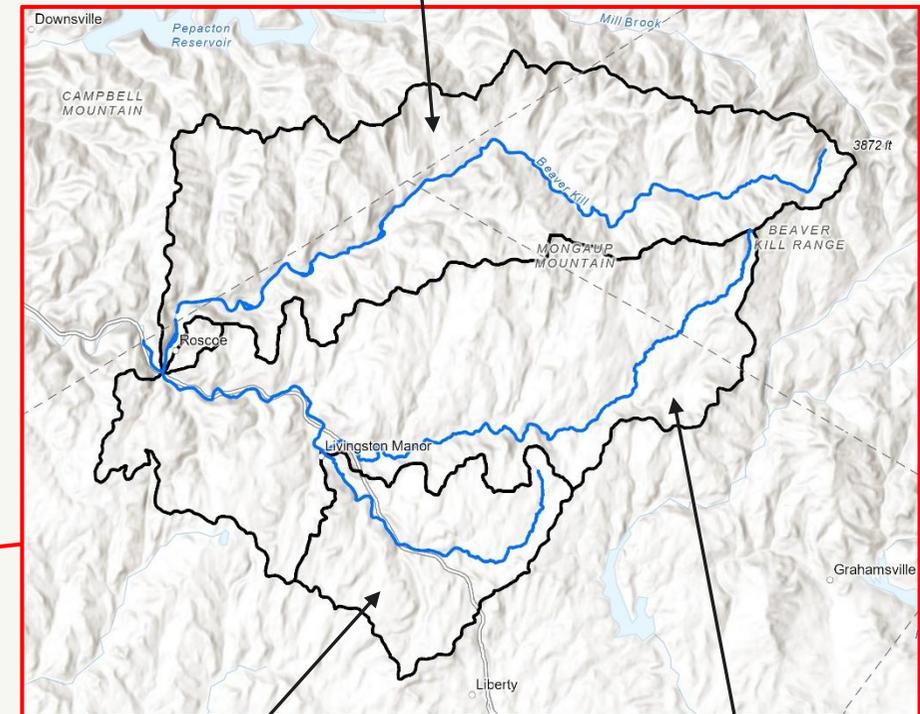
Little Beaver Kill
Watershed Drainage
Area = 30.3 square
miles

Willowemoc Creek
Watershed Drainage
Area =
100.5 square miles

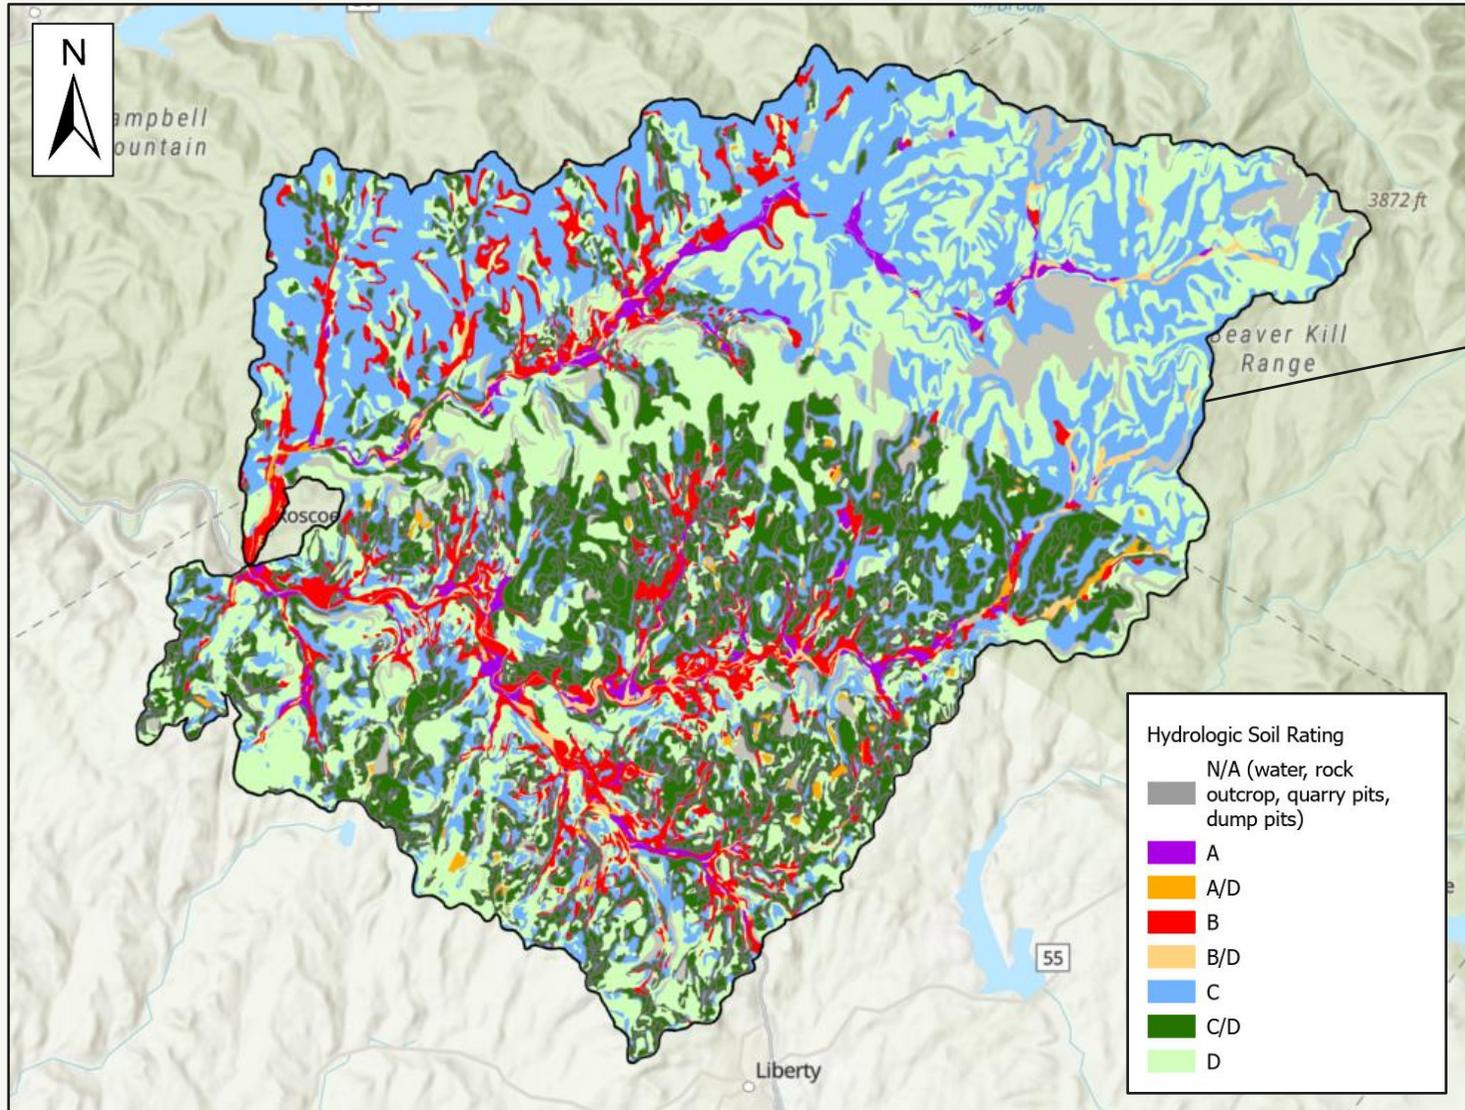
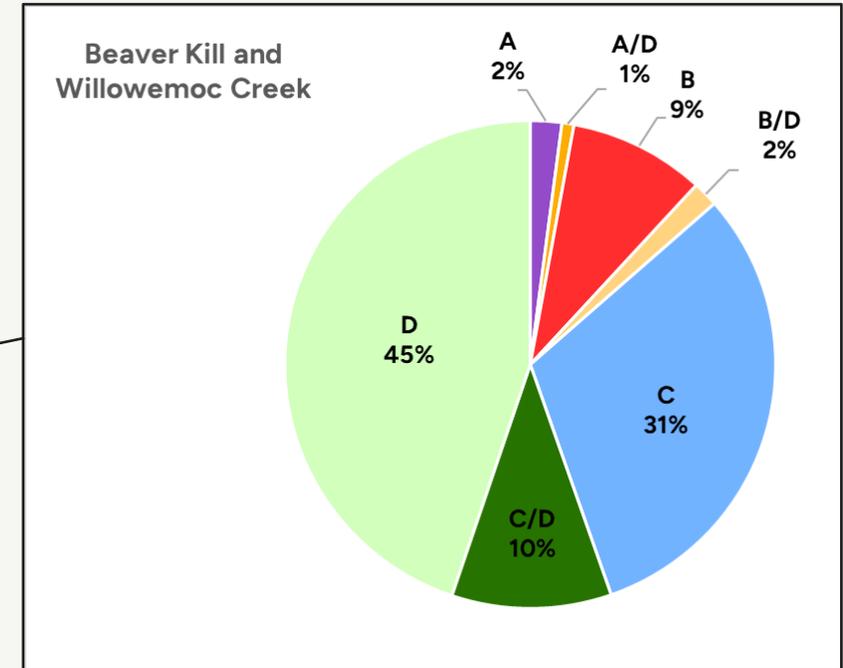
Hydrologic Soil Groups

A - High infiltration, low runoff
B
C
D - Low infiltration, high runoff

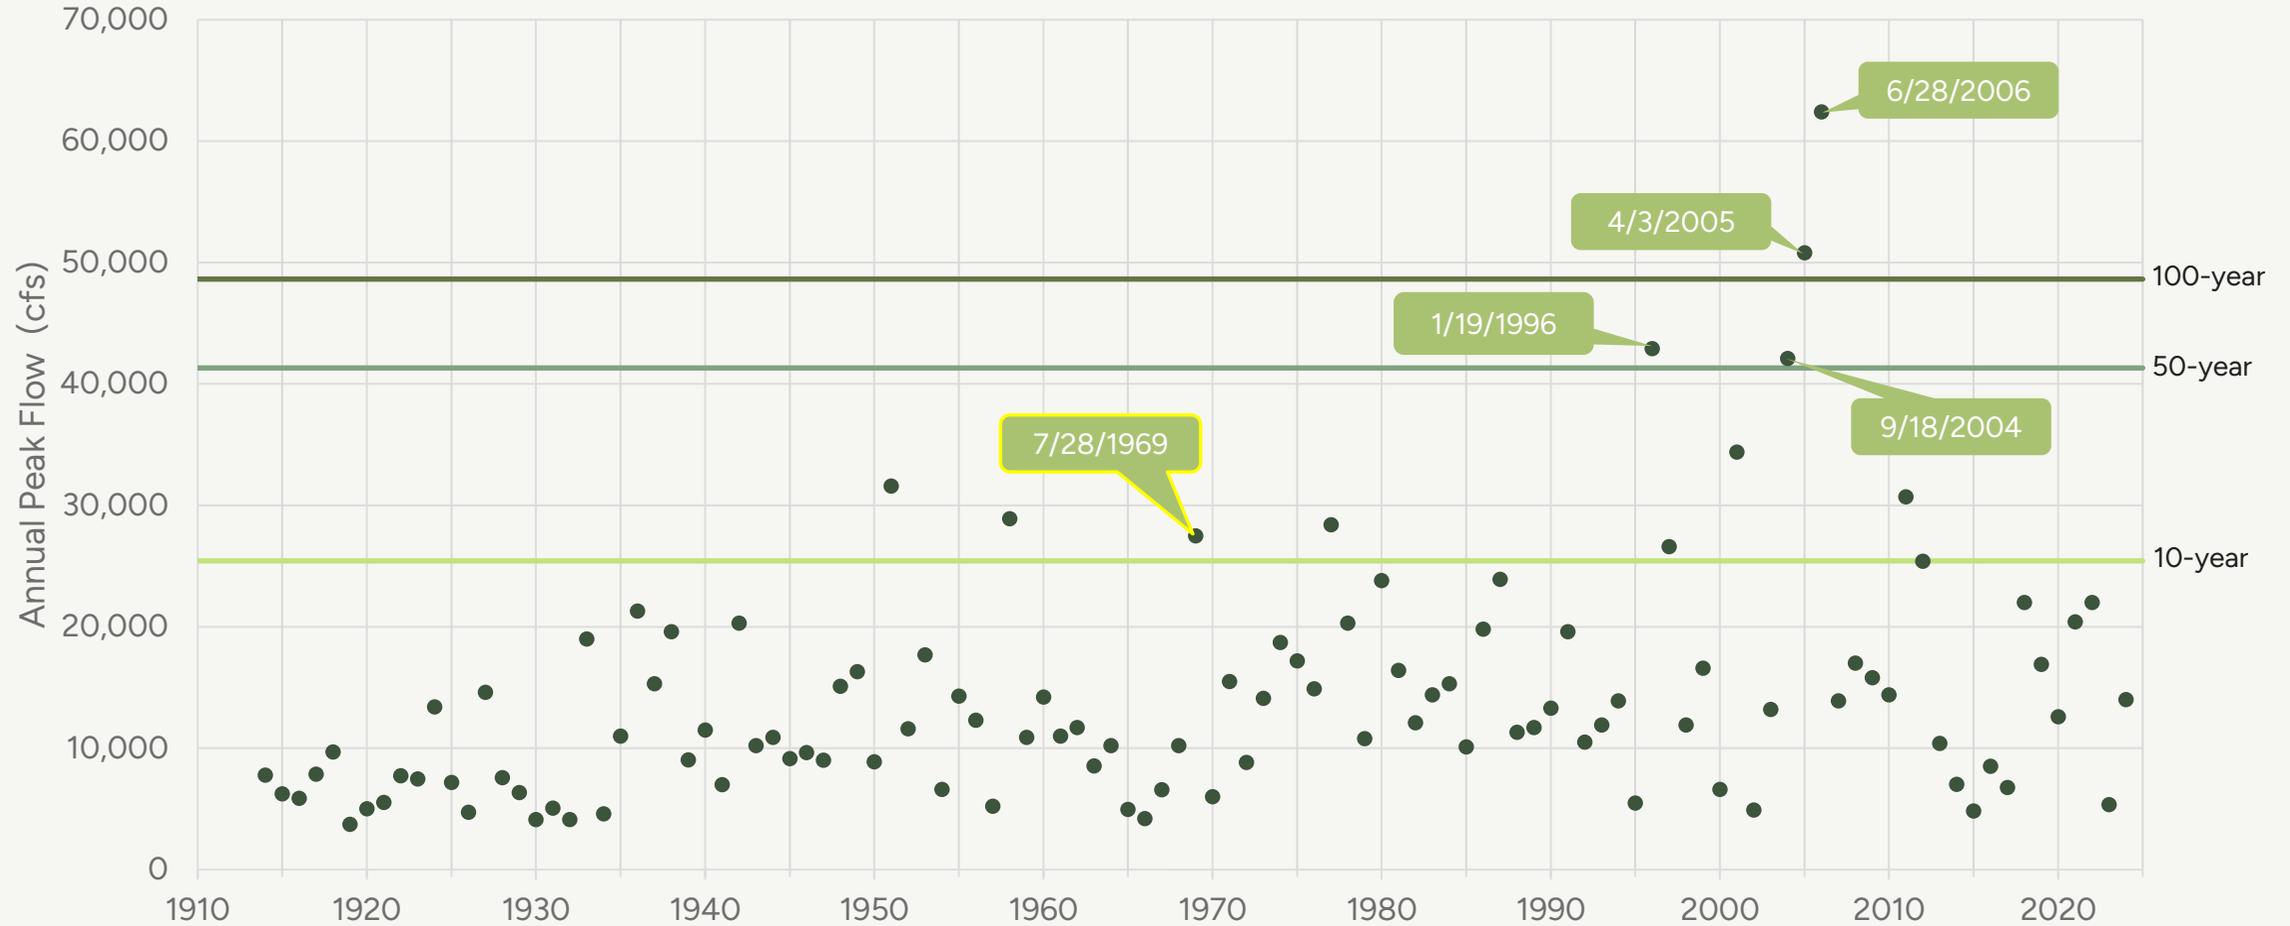
ANNUAL PEAK FLOWS: USGS 01420500 BEAVER KILL AT COOKS FALLS, NY

Gauge Location: USGS Beaver Kill at Cooks Fall, NY

Contributing Drainage: 241 square miles

Period of Record: 1914-2025

Recurrence intervals are from FEMA Flood Insurance Study for Delaware County

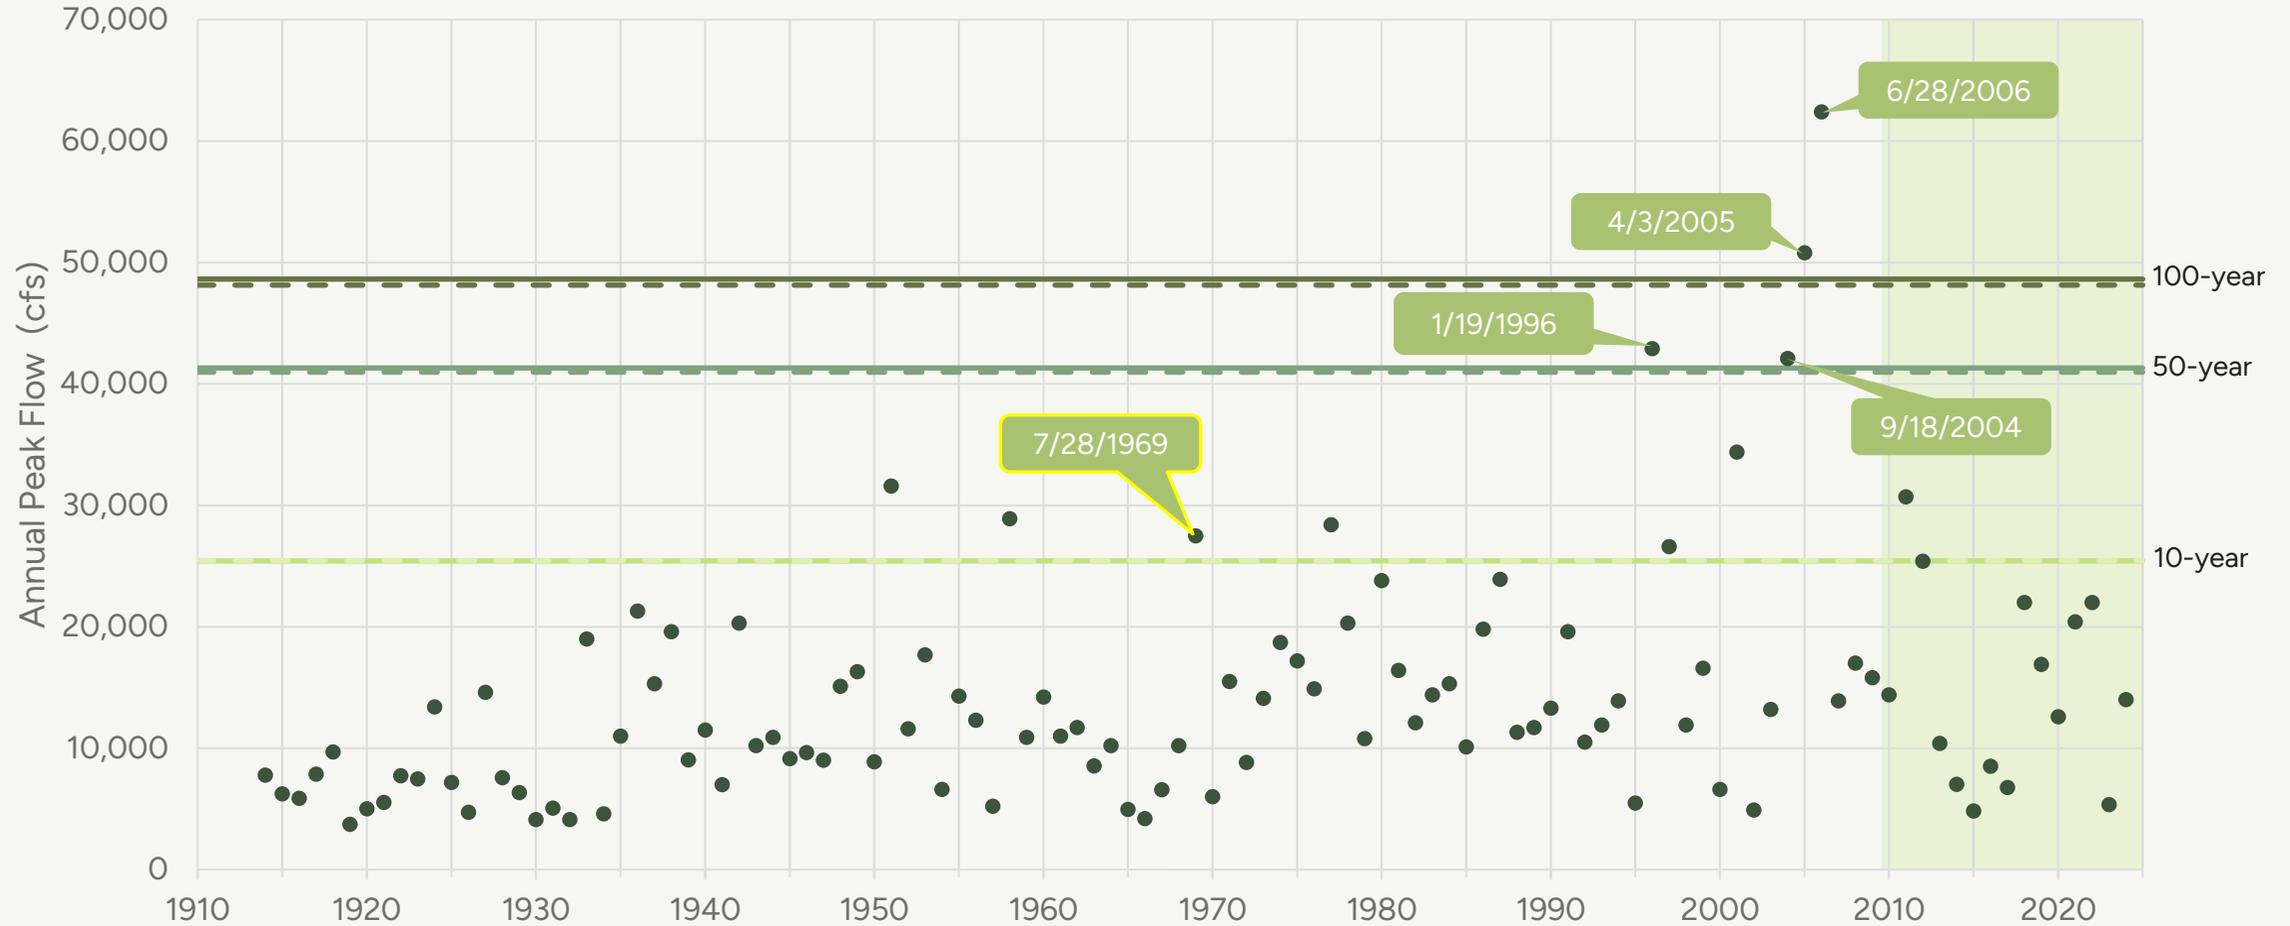
ANNUAL PEAK FLOWS: USGS 01420500 BEAVER KILL AT COOKS FALLS, NY

Gauge Location: USGS Beaver Kill at Cooks Fall, NY

Contributing Drainage: 241 square miles

Period of Record: 1914-2025

Recurrence intervals are from FEMA Flood Insurance Study for Delaware County and updated for current gage record

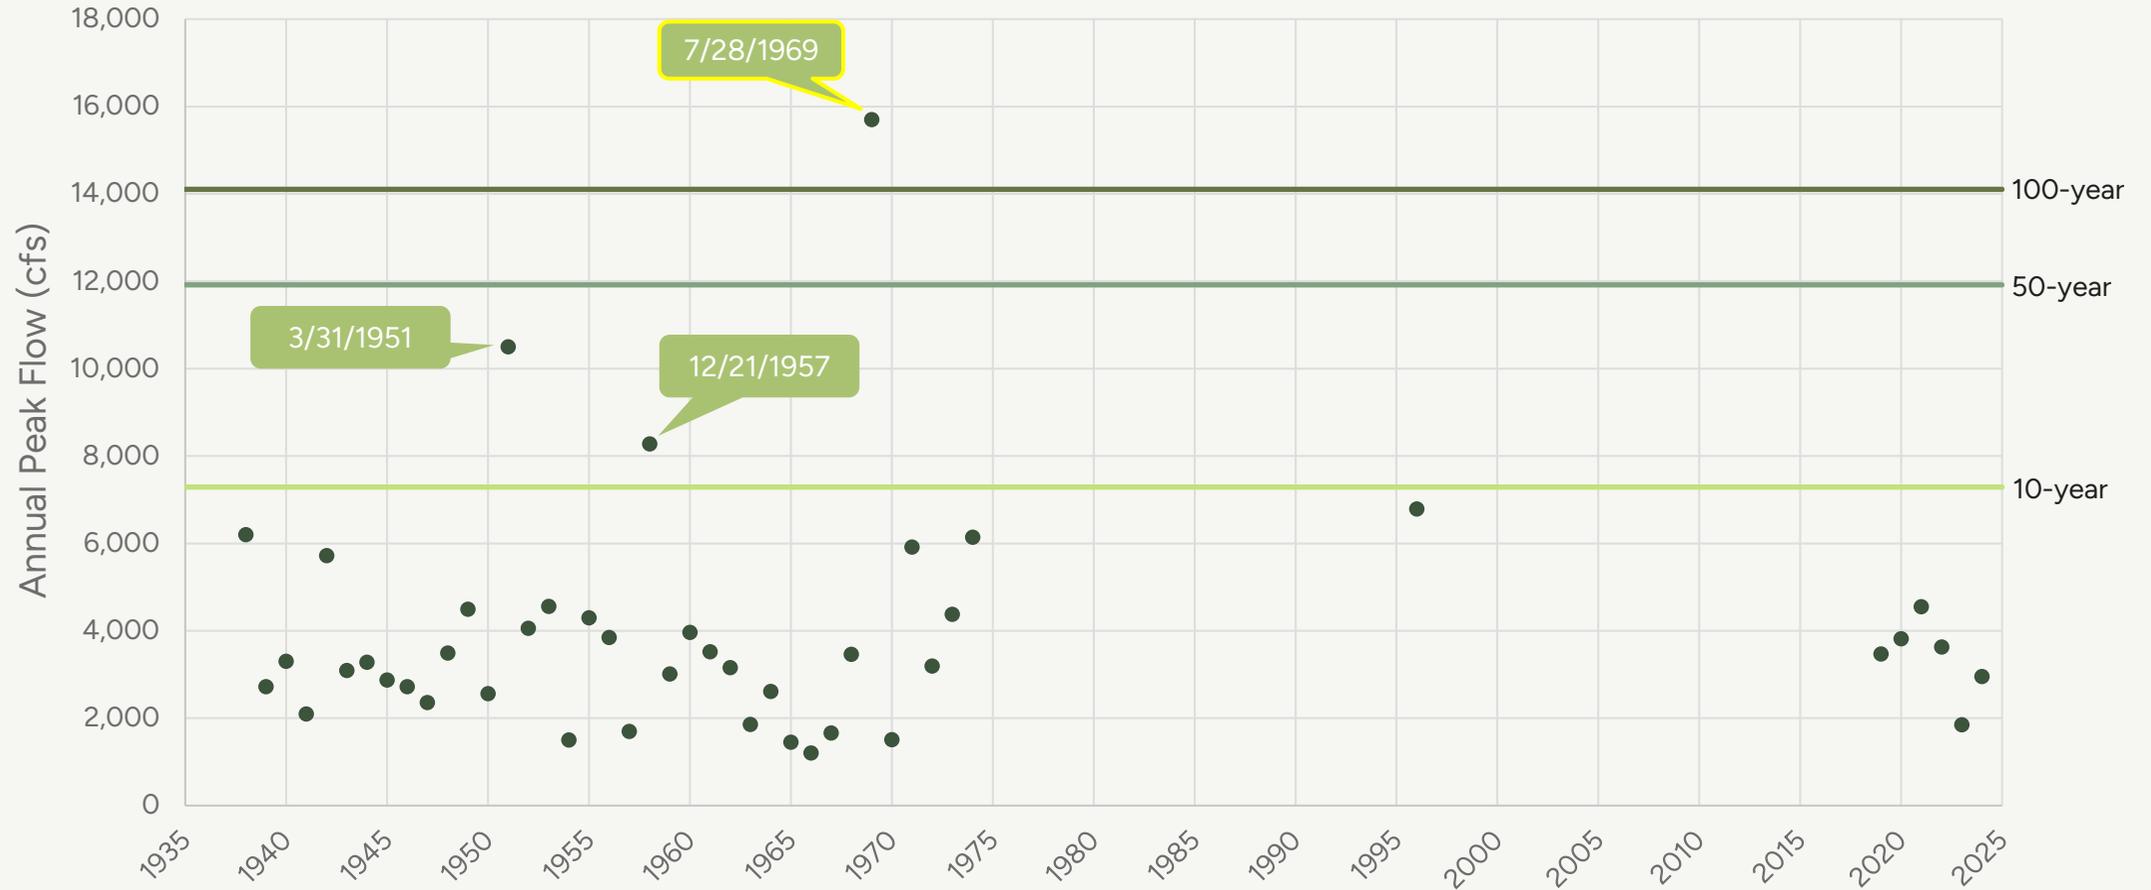
ANNUAL PEAK FLOWS: USGS 01419500 WILLOWEMOC CREEK NEAR LIVINGSTON MANOR, NY

Gauge Location: Willowemoc Creek near Livingston Manor, NY

Contributing Drainage: 62.6 square miles

Period of Record: 1938-1973; 1996; 2018-present

Recurrence intervals are from FEMA Flood Insurance Study for Sullivan County

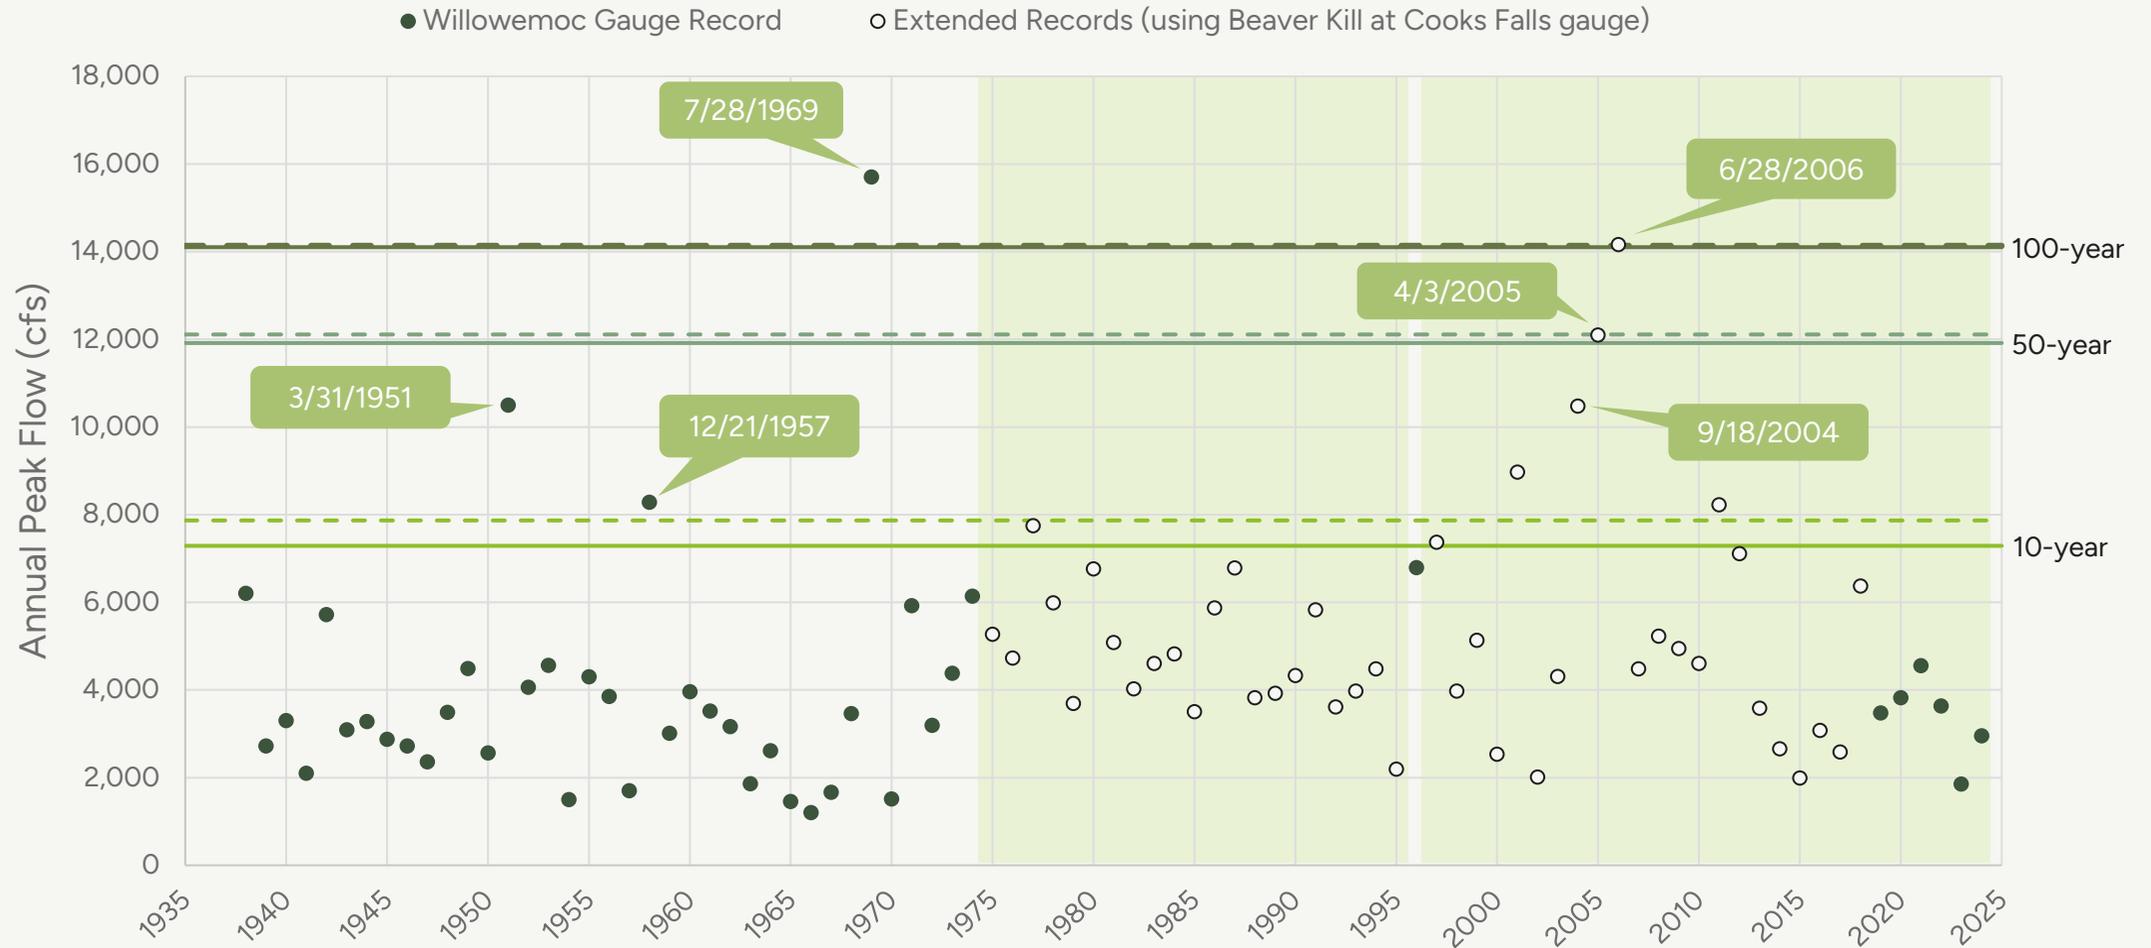
ANNUAL PEAK FLOWS: USGS 01419500 WILLOWEMOC CREEK NEAR LIVINGSTON MANOR, NY

Gauge Location: Willowemoc Creek near Livingston Manor, NY

Contributing Drainage: 62.6 square miles

Extended Period of Record: 1938-2025

Recurrence intervals are from FEMA Flood Insurance Study for Sullivan County and updated with extended gauge record analysis

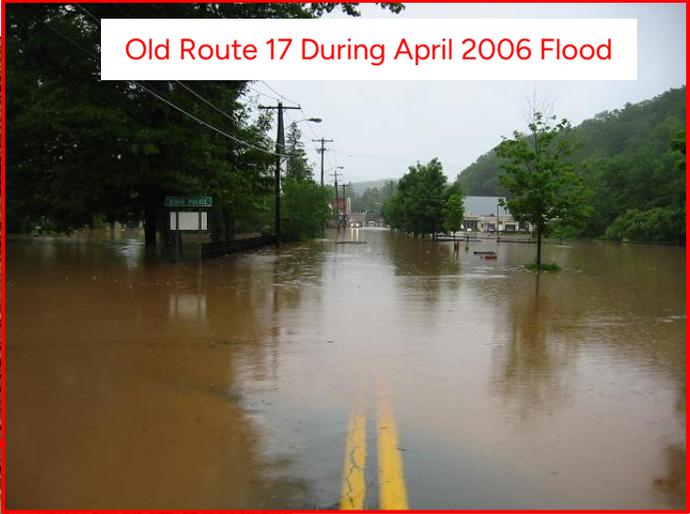
Old Route 17 During April 2006 Flood

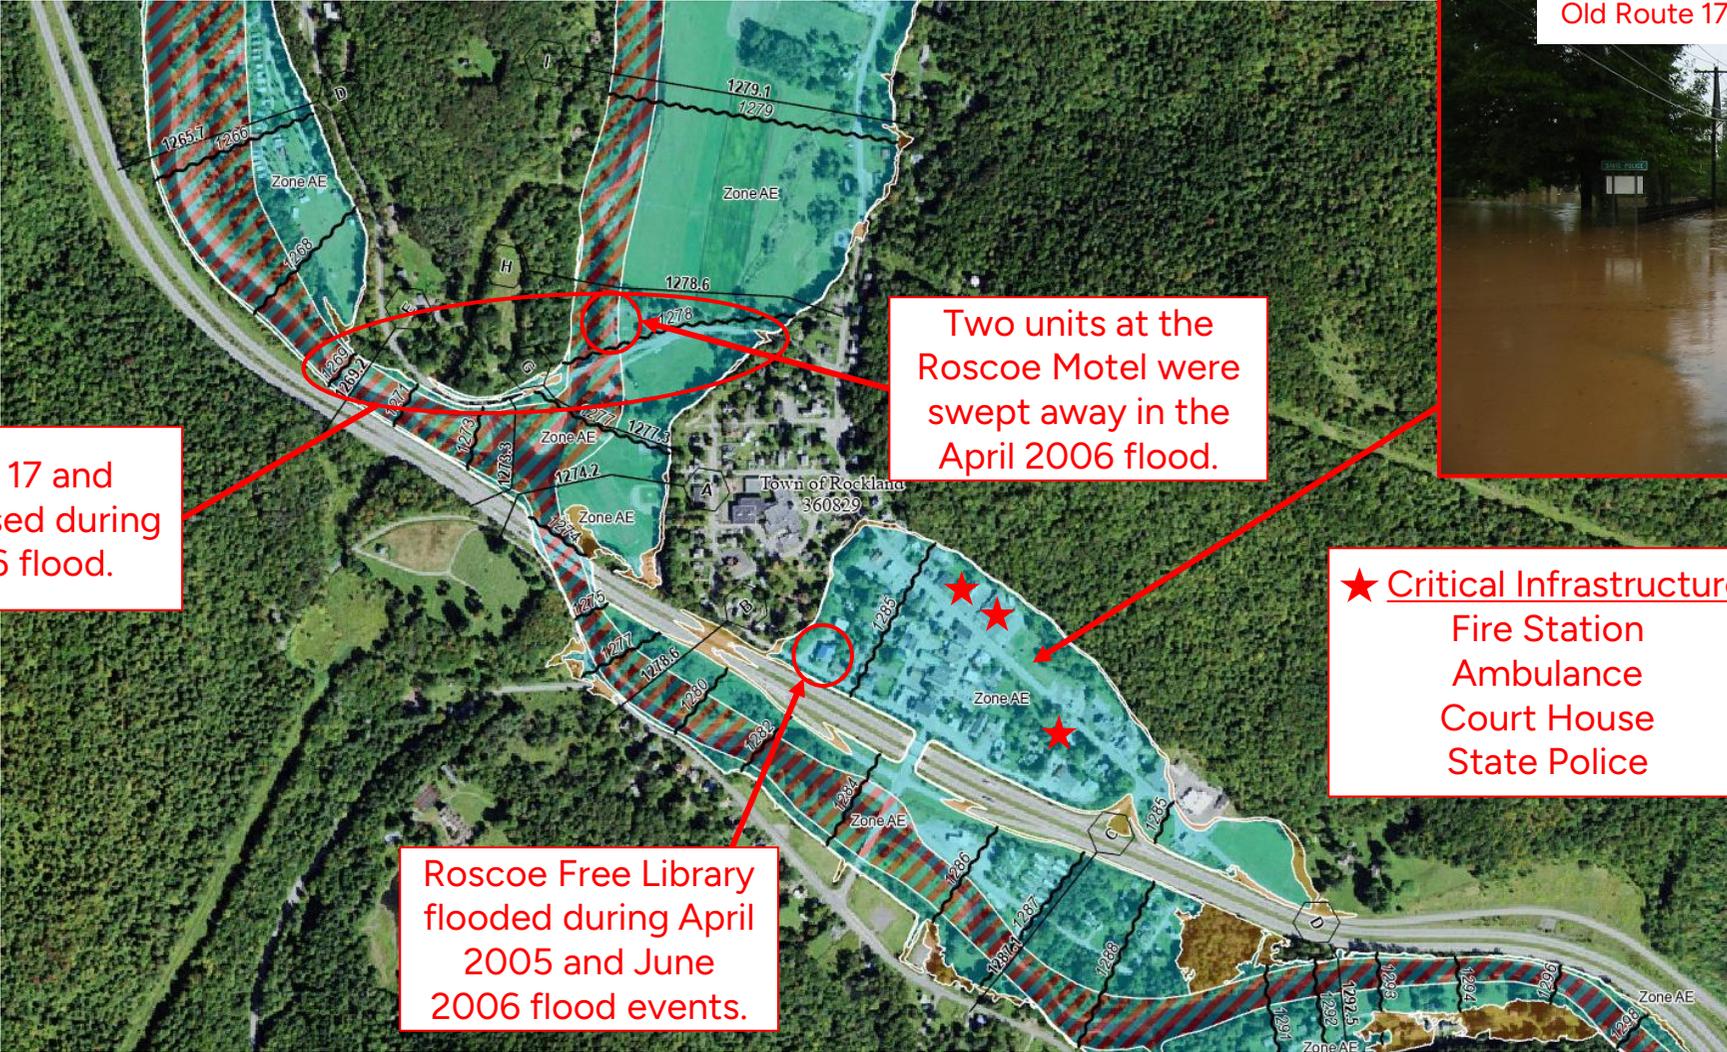
Main downtown area is subject to significant flooding.

Old Route 17 and Route 17 closed during June 2006 flood.

Two units at the Roscoe Motel were swept away in the April 2006 flood.

Roscoe Free Library flooded during April 2005 and June 2006 flood events.

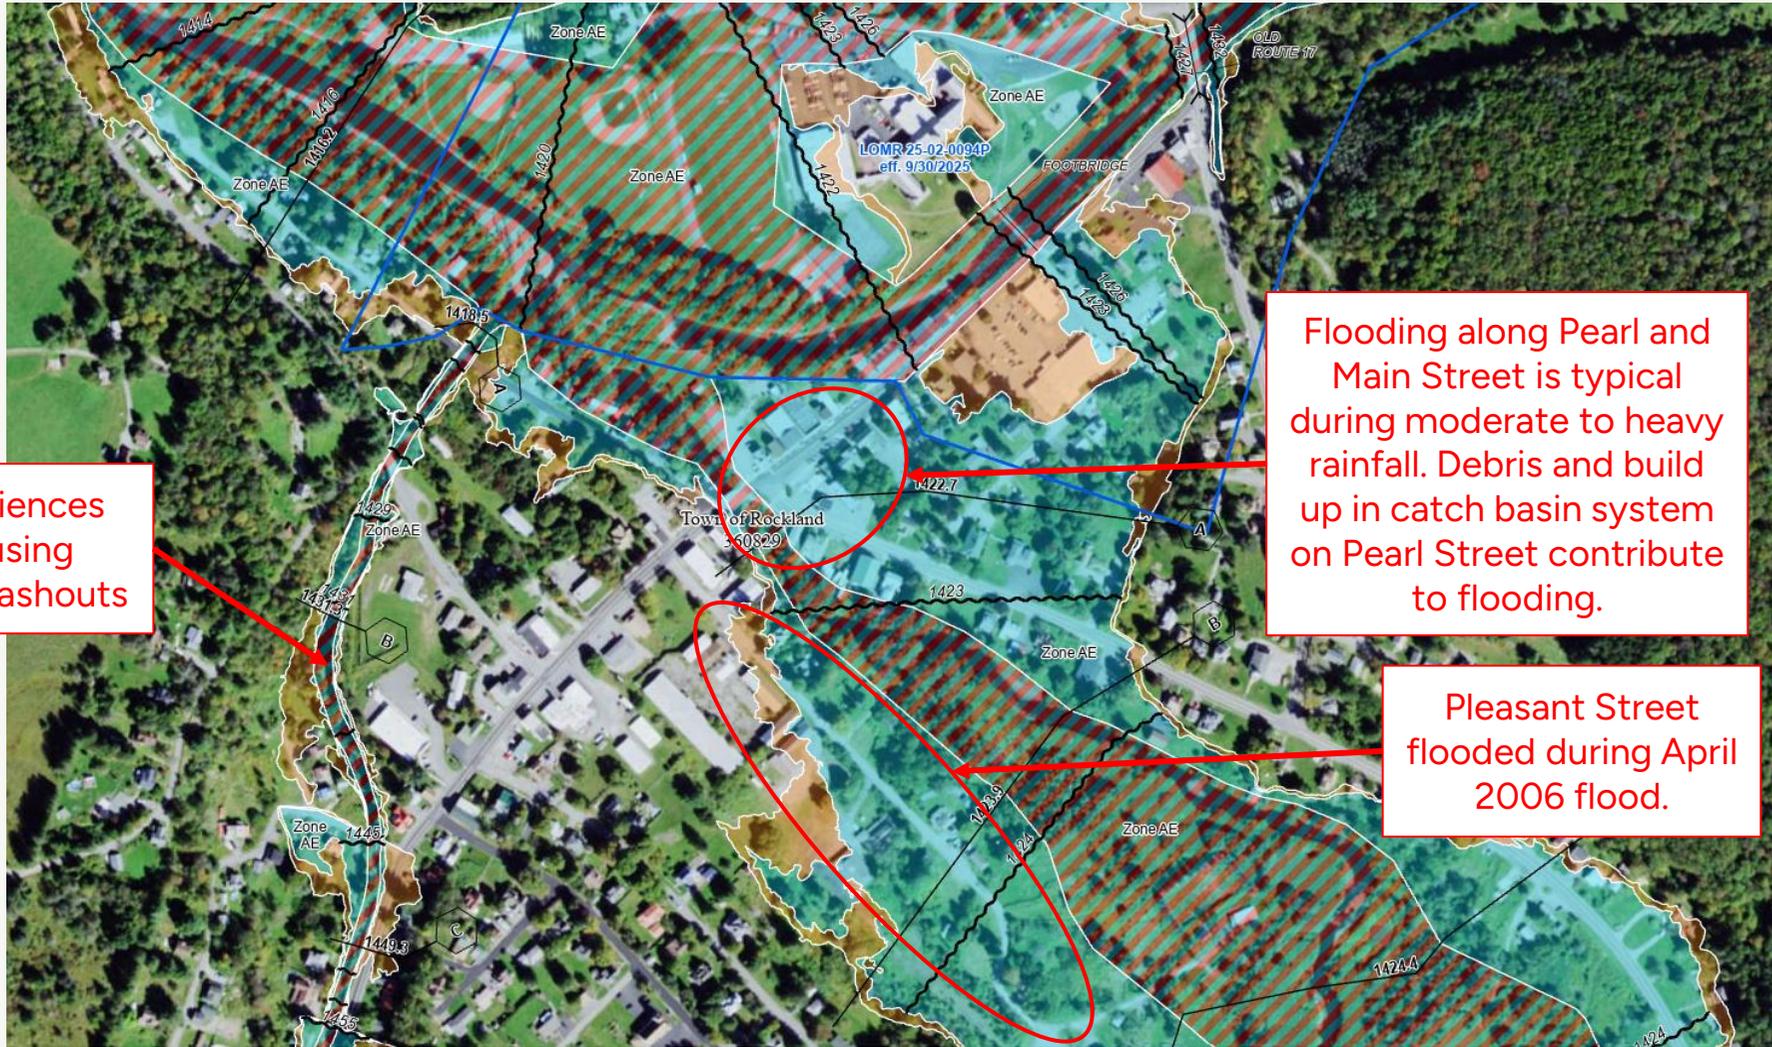
Repetitive flooding resulting in loss of life and property. Main Street is heavily affected during flood events.

Cattail Brook experiences flash flooding causing culvert and bridge washouts

Flooding along Pearl and Main Street is typical during moderate to heavy rainfall. Debris and build up in catch basin system on Pearl Street contribute to flooding.

Pleasant Street flooded during April 2006 flood.

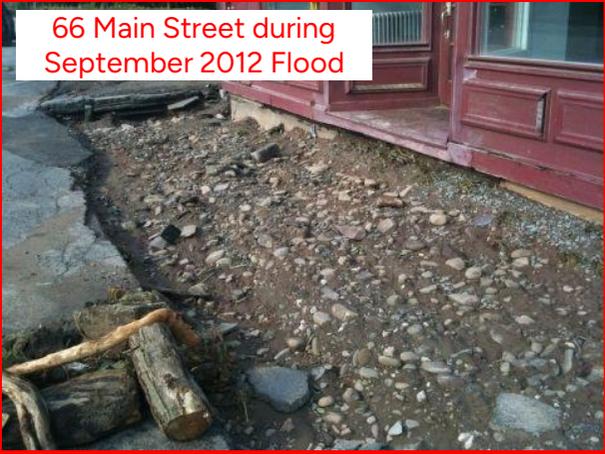
66 Main Street during September 2012 Flood

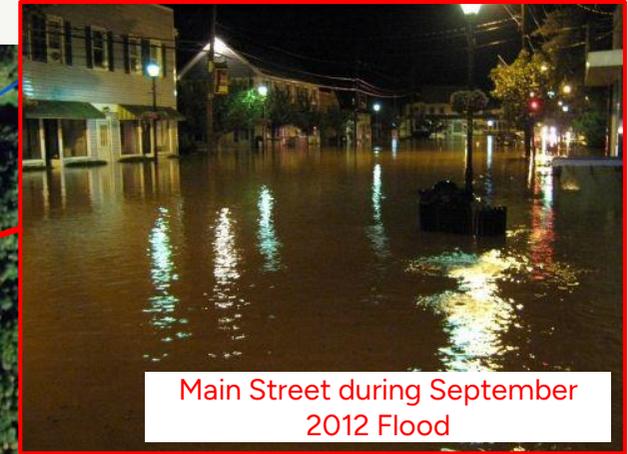
Main Street during September 2012 Flood

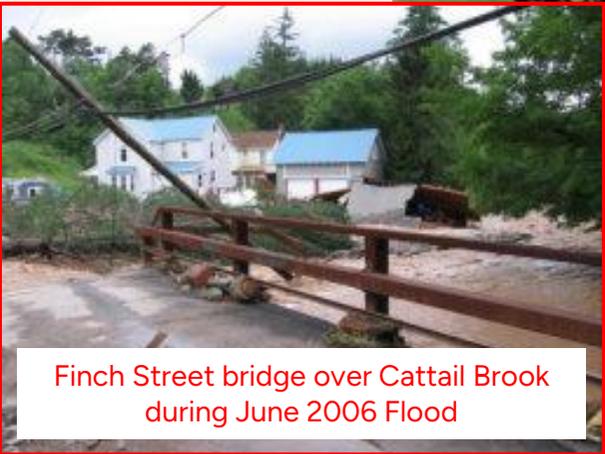
Finch Street bridge over Cattail Brook during June 2006 Flood

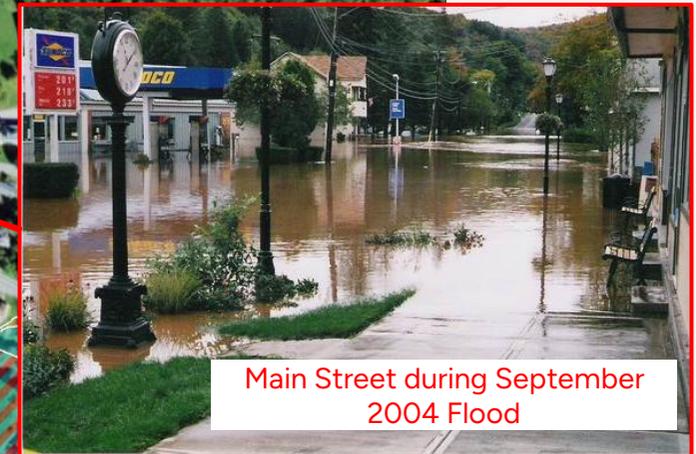
Main Street during September 2004 Flood
